LAKE WALTER DAM

3 NDI I.D. PA-0080
DER I.D. 058-135
OWNER: MR. R. O. WALTER

7 PHASE I INSPECTION REPORT

6 NATIONAL DAM INSPECTION PROGRAM.

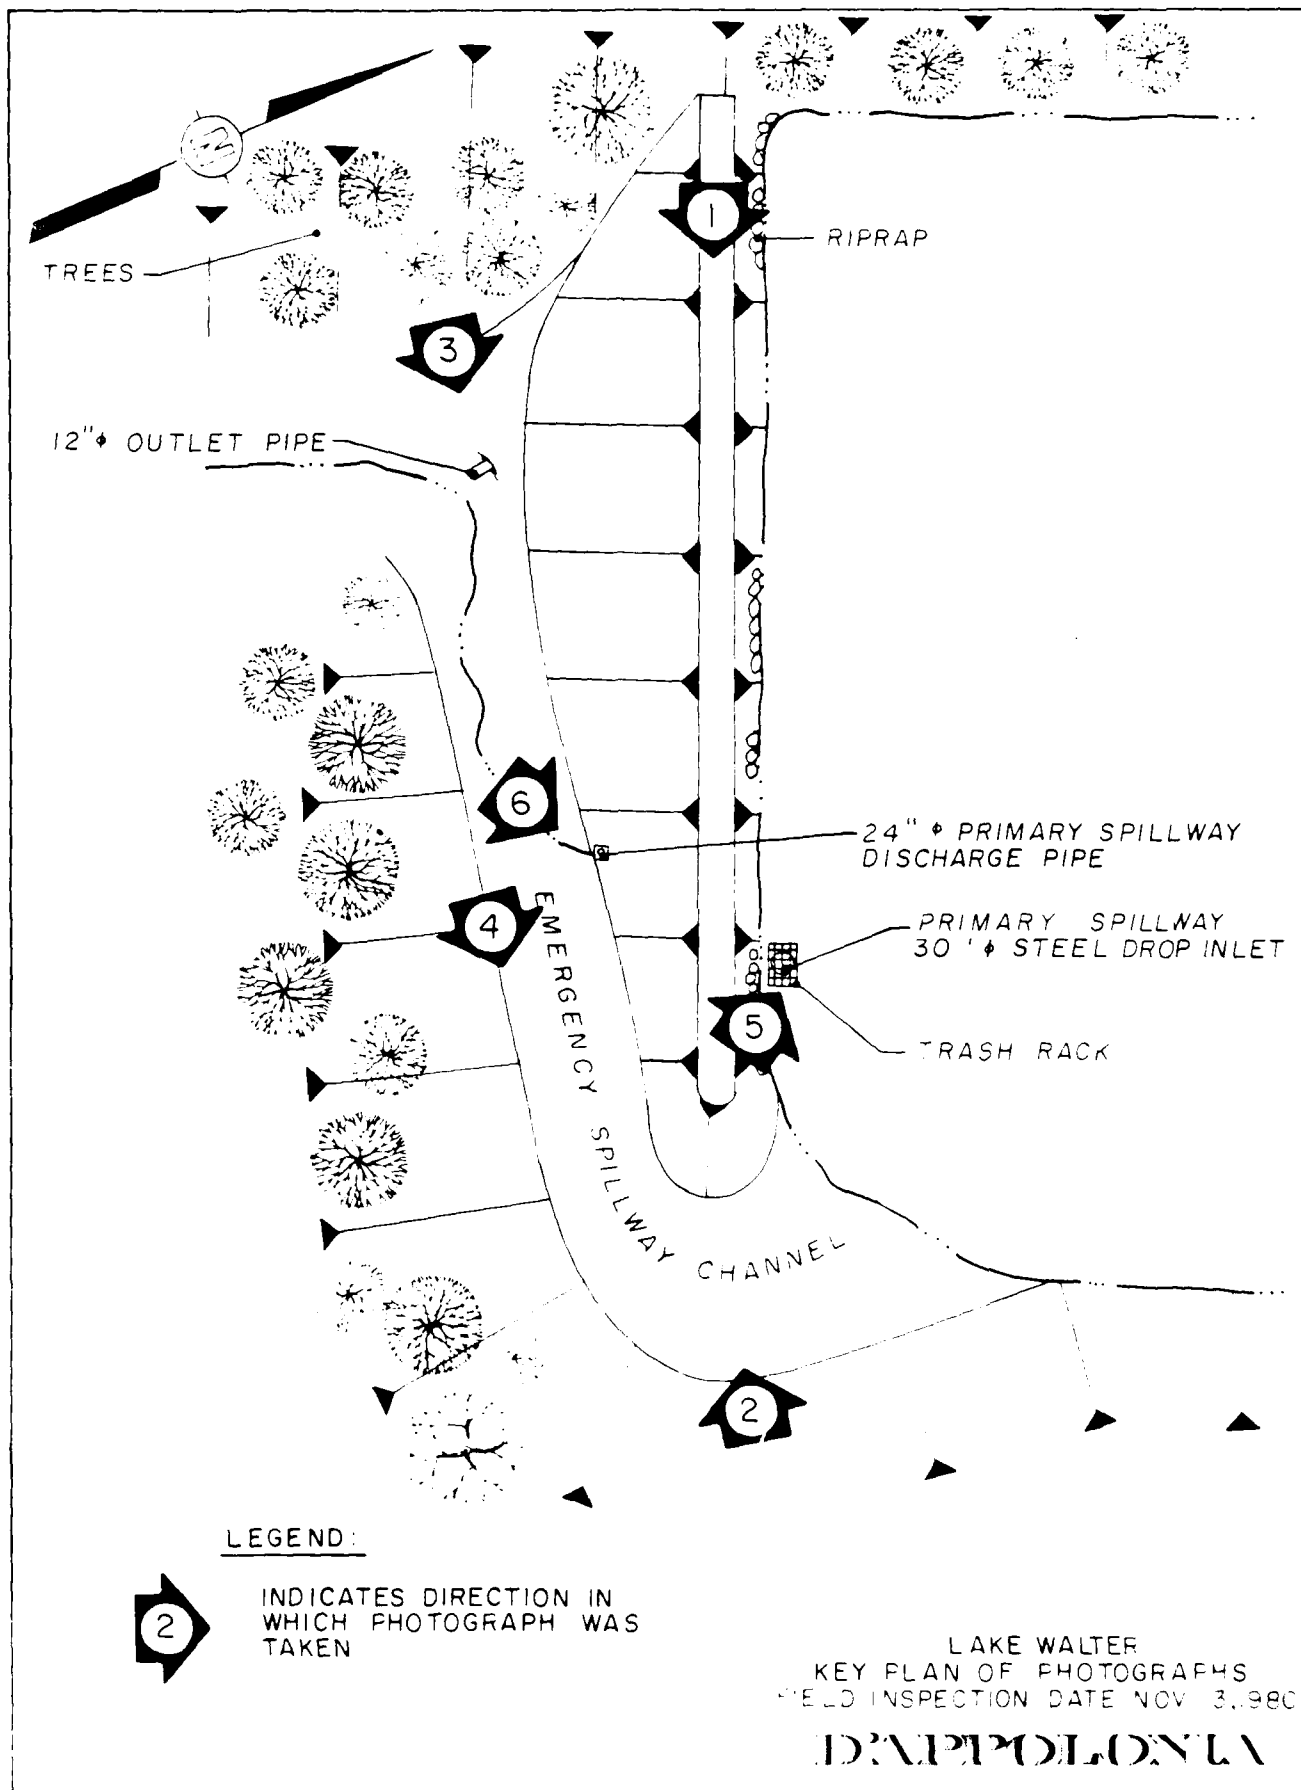
<u>PHOTOGRAPH NO.</u>	<u>DESCRIPTION</u>
1	Crest (looking east).
2	Emergency spillway crest.
3	Downstream face of dam.
4	Emergency spillway discharge channel (looking upstream).
5	Primary spillway intake structure.
6	Primary spillway (downstream end).
7	Highway (mile 1.0).
8	House (mile 1.3).
